CALSPAN ON-SITE AIR BAG DEPLOYMENT INVESTIGATION

CALSPAN CASE NO. 92-10

VEHICLE - 1991 DODGE CARAVAN

ACCIDENT DATE - 1992

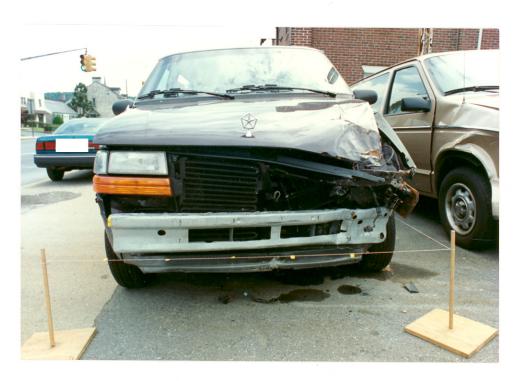
The air bag equipped 1991 Dodge Caravan sustained moderately severe frontal crush from its impact sequence with the side of vehicle #2. Maximum crush was 41.6cm (16.375") located at the left corner of the front bumper reinforcement bar. Direct contact damage on the bumper facia began 28.6cm (11.25") left of center and extended 48.9cm (19.25") to the corner. The bumper facia subsequently separated from the reinforcement bar and contacted the concrete road surface which resulted in abrasions across the full width of the facia. impact deformed the entire frontal area of the vehicle which resulted in a combined induced and direct contact damage of 139.7cm (55.0"). Crush values at the bumper reinforcement bar were as follows: $C_1=41.6cm (16.375")$, $C_2=32.1cm (\hat{1}2.625"), C_3=$ $20.0 \text{cm} (7.875''), C_4 = 9.8 \text{cm}$ (3.875''), $C_5=2.2cm (0.875'')$, $C_6 = -5.1 \text{cm} (-2.0)$.

Frontal View Of The 1991 Dodge Caravan.

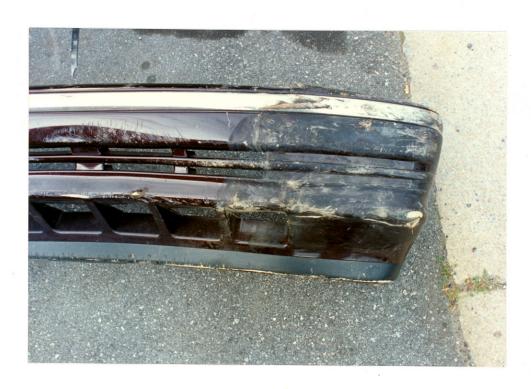
Direct Contact Damage To The Front Bumper Facia.

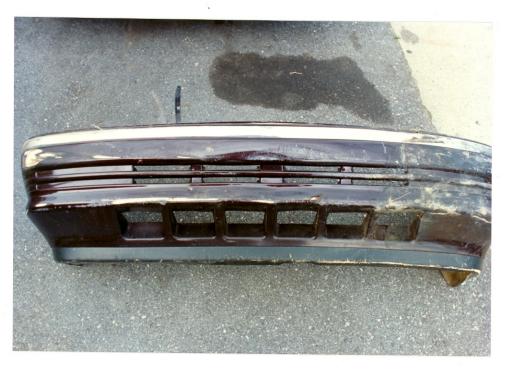
Separated Front Bumper Facia With Road Abrasions Across Entire Width.

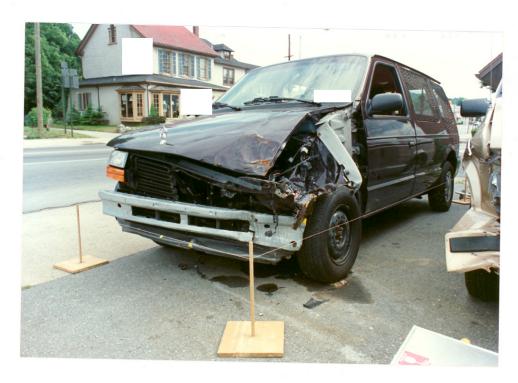
Left Front Three-Quarter View.

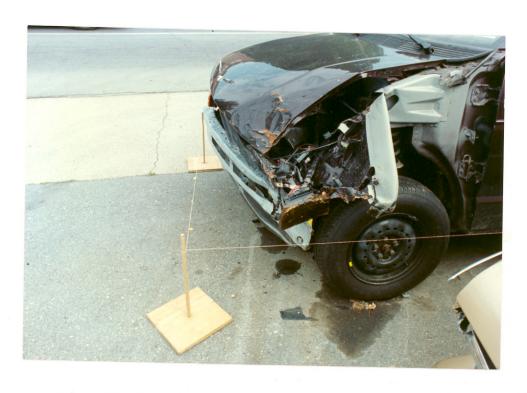
Perpendicular View Showing The Extent Of Crush.

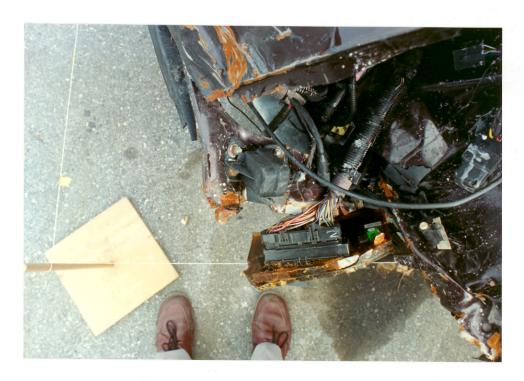
The 1991 Dodge Caravan was equipped with a supplemental driver's side air bag system which deployed as a result of the vehicle's impact sequence with vehicle #2. The system was equipped with two crash sensors that were mounted to the inner surface of the radiator support panel inboard of the front fenders. The right crash sensor was not damaged; however, the left sensor housing was cracked at the inboard mounting location. The wiring harnesses were not damaged.

Damaged Left Front Air Bag Crash Sensor.

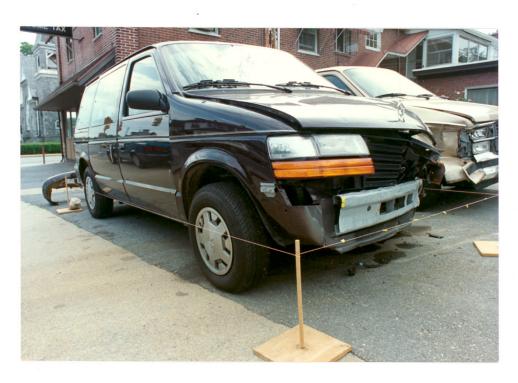
Right Front Three-Quarter View.

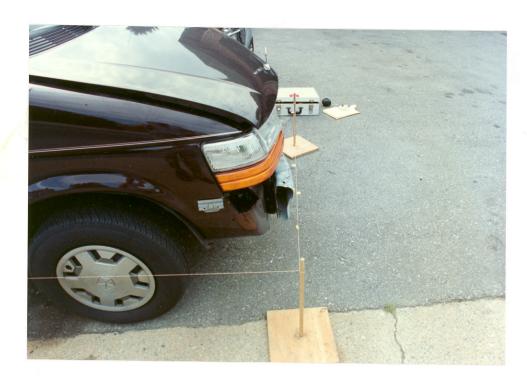
Perpendicular View Of The Right Frontal Area.

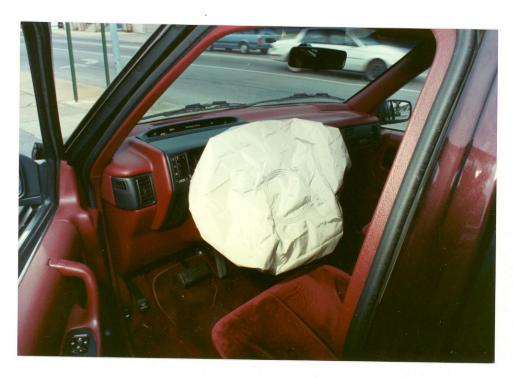
The deployed air bag measured 61 cm (24") in diameter horizontally from seam to seam. The bag was tethered by four internal straps that were sewn to the bag with a 16.2 cm (6.375") diameter tether reinforcement located at the center point of the bag. Three rows of blue stitching attached the tether reinforcement to the face of the bag. There was no damage to the air bag or internal tether straps.

Vehicle's Interior And The Deployed Driver's Air Bag.

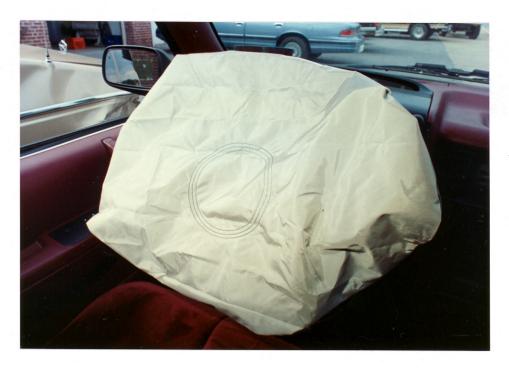
Deployed Driver's Air Bag.

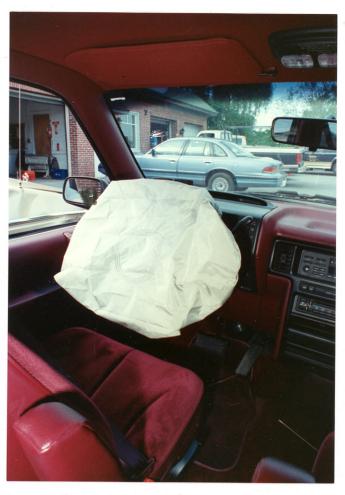
Forward View Of The Driver's Position And The Deployed Air Bag.

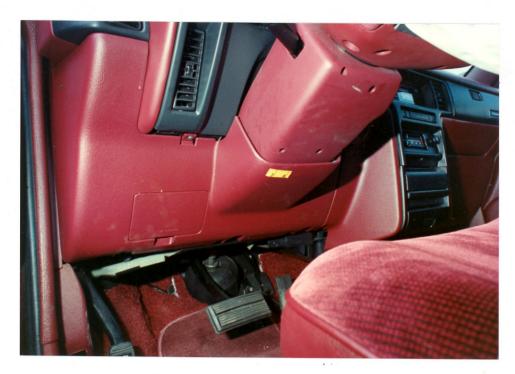
The driver's left knee possibly contacted the knee bolster at the base of the steering column. Although no injury occurred, a small diameter scuff mark was noted to the bolster.

Driver's Left Knee Contact.

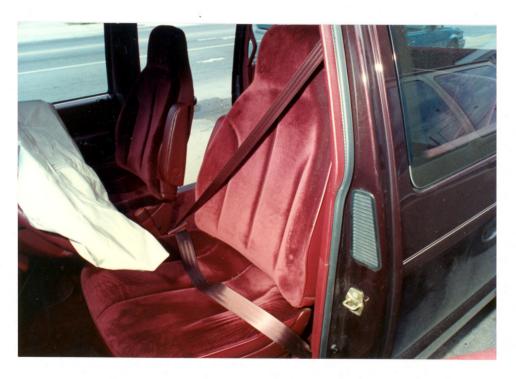
The driver of the 1991 Dodge Caravan was in a normal, upright seated position at impact with both hands bracing against the steering wheel at the 10 and 2 o'clock positions. Her seat was adjusted to a rearward position, 5.1cm (2") from the full rearward position and the seat back was set to a near vertical position. The vehicle was equipped with a standard non-tilting steering column. The driver was properly wearing the active 3-point lap and shoulder belt webbing. Belt usage was supported by driver and police statements, driver injury patterns, the lack of interior occupant contact points, and by routine usage wear marks that were visible on the latchplate. There was no evidence of driver loading on the active belt system.

Driver's Active 3-Point Belt System.

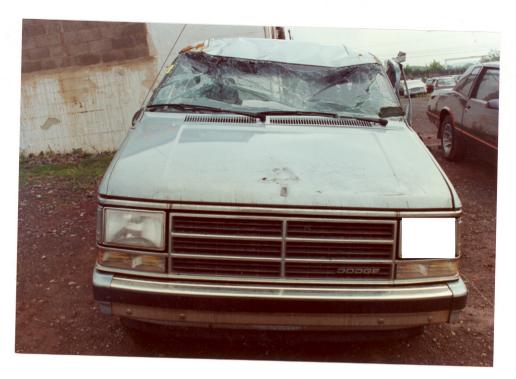
The 1988 Dodge Caravan sustained moderately severe left side damage from its impact sequence with the air bag equipped minivan. Direct contact damage began on the left front wheel, 15.2cm (6") rearward of the axle position, and extended rearward 330.5cm (130.1") across the dogleg of the left front fender, left door, and the left quarter panel. The direct contact damage ended at the left corner of the rear bumper. Maximum crush was 21.9 cm (8.625"). located on the lower crease of the left quarter panel 17.8cm (7") rearward of the left B-pillar. Crush values at the lower body crease level were as follows: $C_1=4.4$ cm (1.75"), $C_2=$ 14.6cm (5.75"), $C_3=19.1$ cm (7.5"), $C_A = 20.0 \text{cm} (7.875^{"}), C_5 = 14.3 \text{cm}$ (5.625''), $C_6=0.0cm (0.0'')$. The left door was jammed closed due to exterior deformation.

Frontal View Of The 1988 Dodge Caravan.

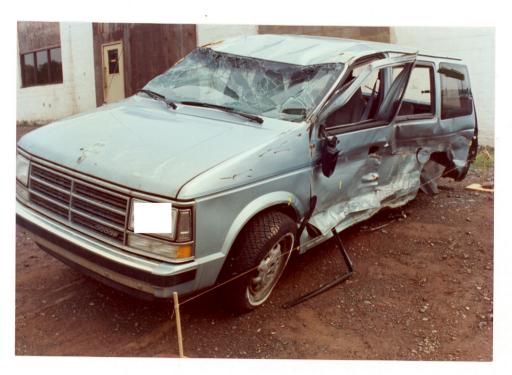
Left Front Three-Quarter View.

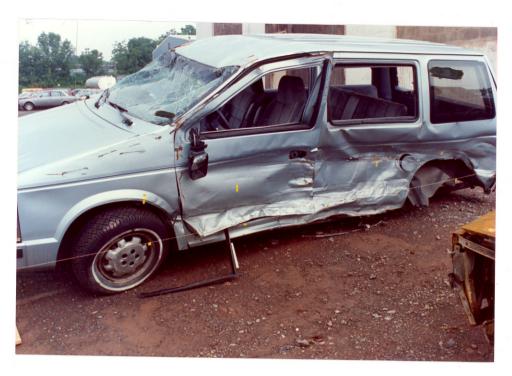
As the bumper of the air bag equipped Dodge Caravan engaged with the left side of vehicle #2, it contacted the left rear tire and wheel and fractured the axle which resulted in complete separation of the tire, wheel, and brake assembly.

Initial Impact Damage To The Left Side Of The 1988 Caravan.

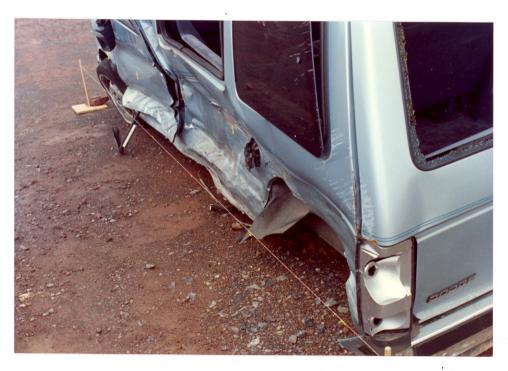
The 1988 Dodge Caravan sustained moderately severe left side damage that began on the left front wheel and extended down the entire length of the van. Maximum crush was 21.9 cm (8.625") located at the lower body crease 17.8 cm (7") rearward of the left B-pillar. The Field L was 330.5 cm (130.1") with the following crush values: C_1 =4.4 cm (1.75"), C_2 =14.6 cm (5.75"), C_3 =19.1 cm (7.5"), C_4 =20.0 cm (7.875"), C_5 =14.3 cm (5.625"), C_6 =0 cm (0"). The front bumper of the 1991 Caravan impacted the left rear tire and wheel of the '88 Caravan with sufficient force to fracture the left rear axle which resulted in complete separation of the wheel and brake assembly.

Longitudinal View Showing The Extent Of Crush.

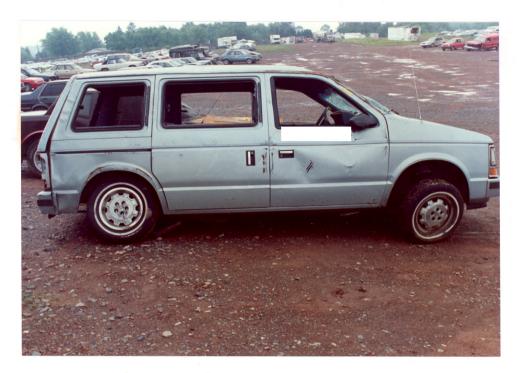
overturned on the concrete road surface. The vehicle initiated a side-over-side rollover sequence leading with its right side. Direct contact damage (i.e., abrasions) began on the right front fender flare at the axle position and extended 358.1cm (141") to the rear corner. The direct contact damage extended vertically up the right A-pillar and down the full length of the side rail. The vehicle's contact with the ground deformed the right roof gutter downward which prevented the right doors from opening. As the vehicle continued onto its roof, the van was pitched with its front side down due to the front wheel drive forward weight distribution. The paint abrasions were distributed across the full width of the roof and extended 25.4cm (10") rearward of the right B-pillar. The remainder of the roof was not damaged. The hood sustained direct contact damage that extended 71.1cm (28") left of center and 40.0cm (18.5") right of the centerline. Maximum roof crush was 8.9cm (3.5") located at the windshield header directly above the steering column. Rollover damage also extended the full length of the left side of the vehicle. The left rear quarter window was opened during the rollover and was scratched, but not broken. All other side glass and the backlight were shattered during the rollover. The windshield was cracked due to deformation of the A-pillars and the windshield header. There was no bond separation or laminant tears in the windshield.

Right Side View.

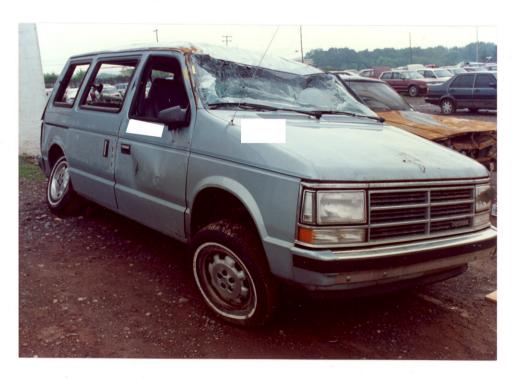
Right Front Three-Quarter View.

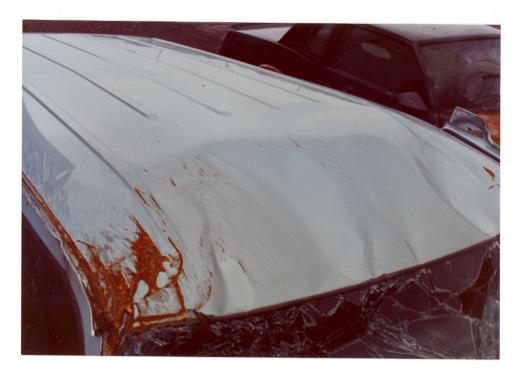
Rollover Damage To The Roof Area Of The 1988 Caravan.

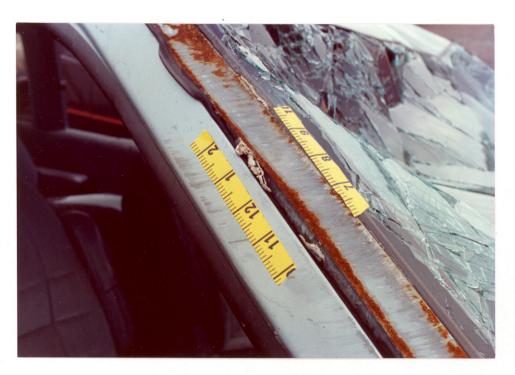
There was no residual damage to the vehicle's interior that resulted from occupant contact. The driver probably contacted the left door panel and armrest during the collision sequence. The passenger's left foot exited the right front door opening during the rollover and was subsequently crushed between the right A-pillar and the road surface. White sneaker fragments were embedded between the A-pillar and the door window frame and also between the windshield molding and the A-pillar.

Sneaker Fragments In The Right A-Pillar/Door Window Frame.

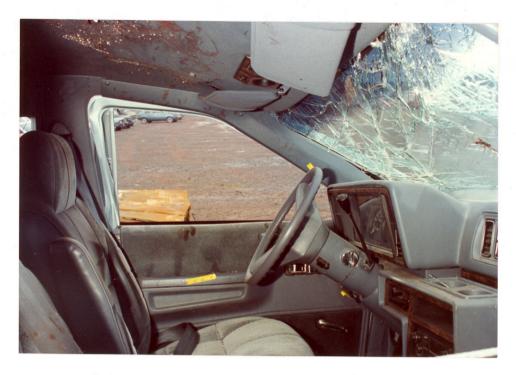
Driver's Seated Area And Contact Points.

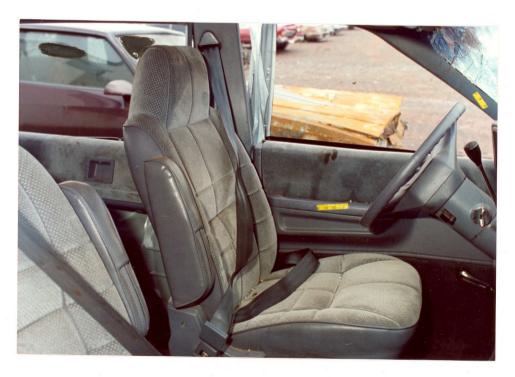
The driver of vehicle #2 was in a normal seated position at impact. She was fully restrained by the active 3-point lap and shoulder belt system. Belt usage was supported by driver and police statements, heavy routine wear marks on the latchplate, the post-crash position of the belt webbing (jammed retractor), and the lack of contact points and/or ejection of the driver.

Driver's Seat And Active Restraint System.

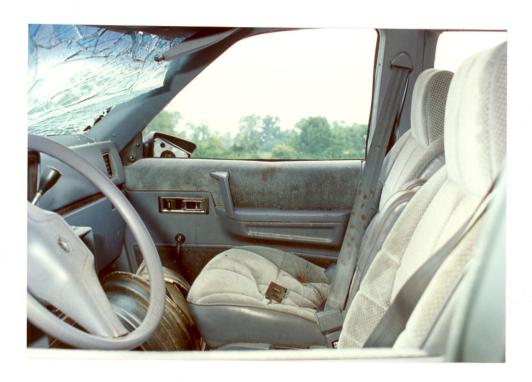
The right front passenger of vehicle #2 was in a normal seated position pre-crash as stated by the driver of the vehicle. She was properly restrained by the active 3-point lap and shoulder belt system. Belt usage was confirmed by driver statements, heavy routine wear marks on the latchplate, blood stains on the belt webbings, and the lack of ejection of the right front passenger. There was no loading evidence on the belt system.

Right Front Occupant's Seat Position And Active Belt System.
